Field Report for Airborne Data Collected In Support of US EPA Region VI Clean Solvents Recycling Fire 6 April 2018

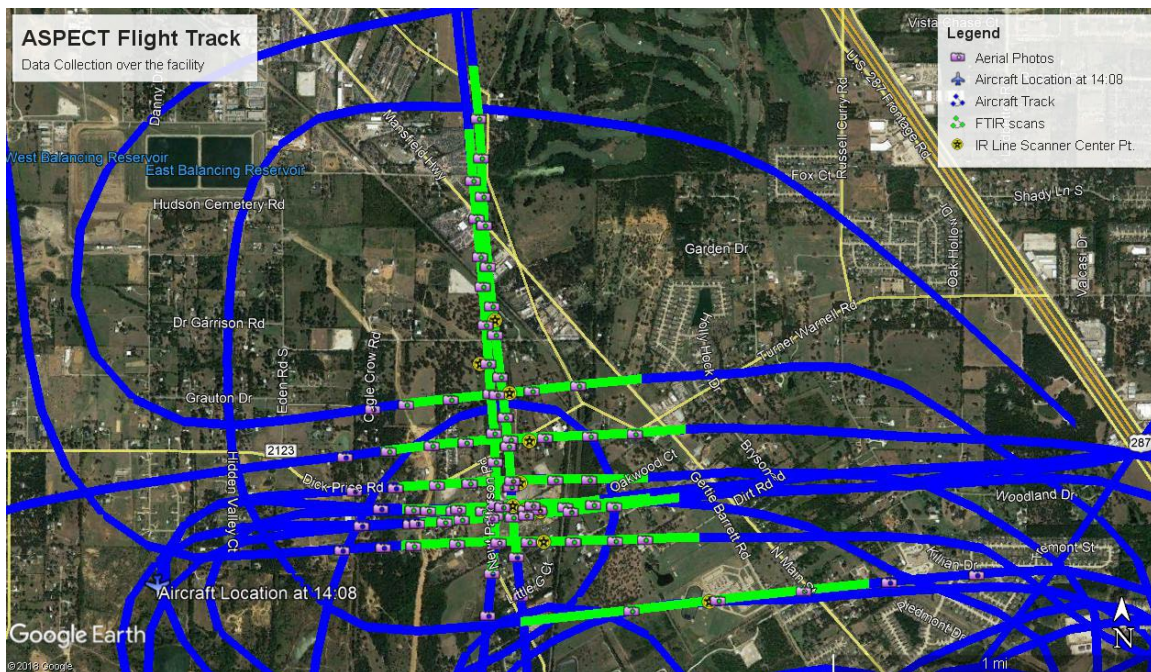
The order to launch the aircraft was given 0655 local on 6 April 2018 and the aircraft was airborne at 0755. The initial data collection run over the site was at 0822 (local) The aircraft made a total of 15 data collection passes; flight information is summarized in Appendix A and Figure 2.

Figure 2: Data collection passes, Clean Solvents Recycling, Mansfield, TX

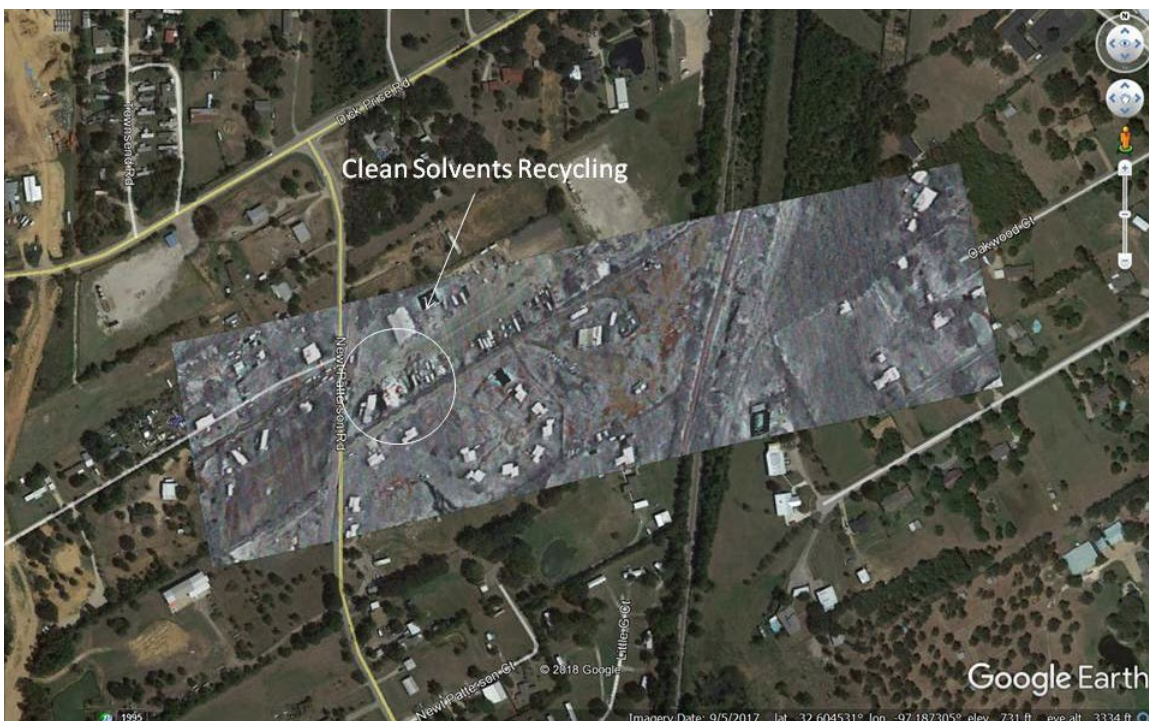
A total of 1 test and 12 data passes were made in the proximity of the site and an infrared line scanner images were generated for each pass. It should be noted that the RS800 line scanner is configured for optimal image generation at an altitude of 853 m above ground level (AGL)(2800 ft). Since the cloud ceiling was just above 213 m (700 ft) all IR imagery exhibited under-scanned distortion. This distortion makes objects in the direction of flight appear longer than they. IR and spectral content are not affected by this type of distortion. Figure 3 shows a typical 3-band image obtained from data collected for Run 10. The highlighted area shows the location of the facility. Examination of the detail shows slightly elevated temperatures in relation to the surrounding area (white is hot). By this time in the life of the fire, personnel had foamed the fire and greatly reduced the thermal signature of the fire. An IR plume was not observed on any of the collection flights.

Figure 3: – 3 band IR image, Run 15, Tri-Chem Industries

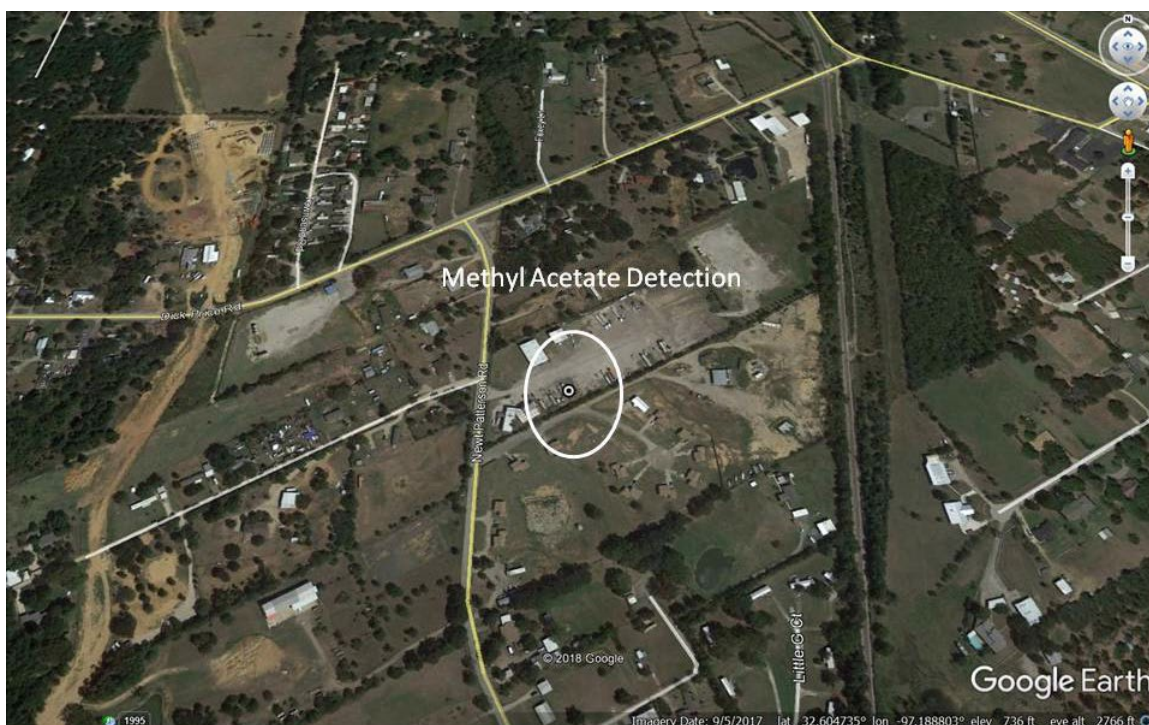
Methyl acetate was the only compound detected on this mission and the detection of 1.2 ppm was just above the detection limit for the system (figure 4 and table 3). Figure 5 shows the spectra of the detection with characteristic peak near 1030 and 1300 wavenumbers. The peak below 800 wavenumbers is CO₂. It should be noted that the apparent baseline shift of the data is due to the passive nature of the data. The concentration reported by the system is likewise confirmed due to the low signal to noise ratio (approximately 3) of the data. The detection was made immediately downwind of the fire as part of data run 10. No other data passes showing detectable results for any other compounds. Based on limited information about the facility, the detection of this compound is consistent with recycled paint and lacquer solvents. The low concentration

of the compound suggests that limited quantities were on site, material was not involved in the fire, or the bulk of material burned up

Figure 4: Chemical Detection Locations, Clean Solvents Recycling

ASPECT was dispatched at the request of the EPA Region VI emergency response program to provide air monitoring of the Clean Solvents Recycling fire. ASPECT arrived on-site at 0822 (local) and began the first of 12 data collection passes. Methyl acetate was detected on pass 10 north east of the fire at a concentration of 1.2 ppm. No other compounds were detected. IR imagery collected over the fire tended to show fairly low temperatures as a result of ongoing fire fighting operations.

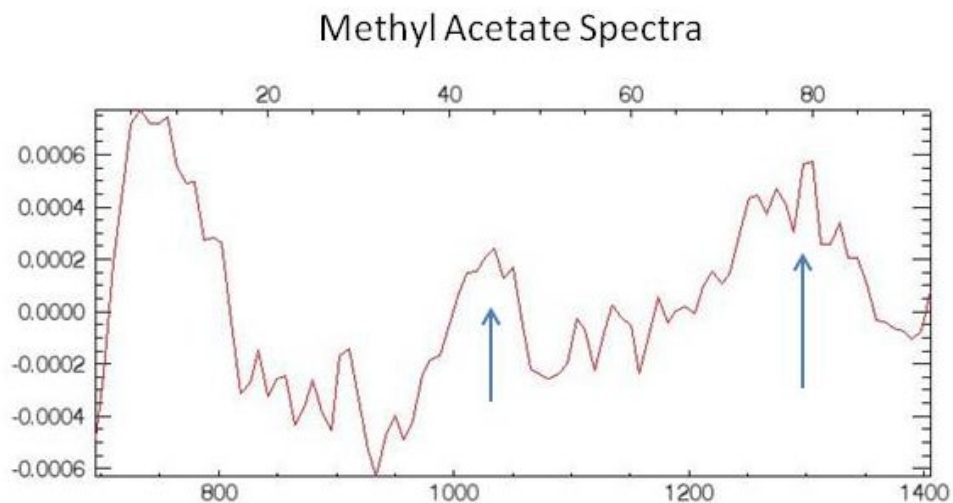
Figure 5: Methyl Acetate Spectra, Clean Solvents Recycling

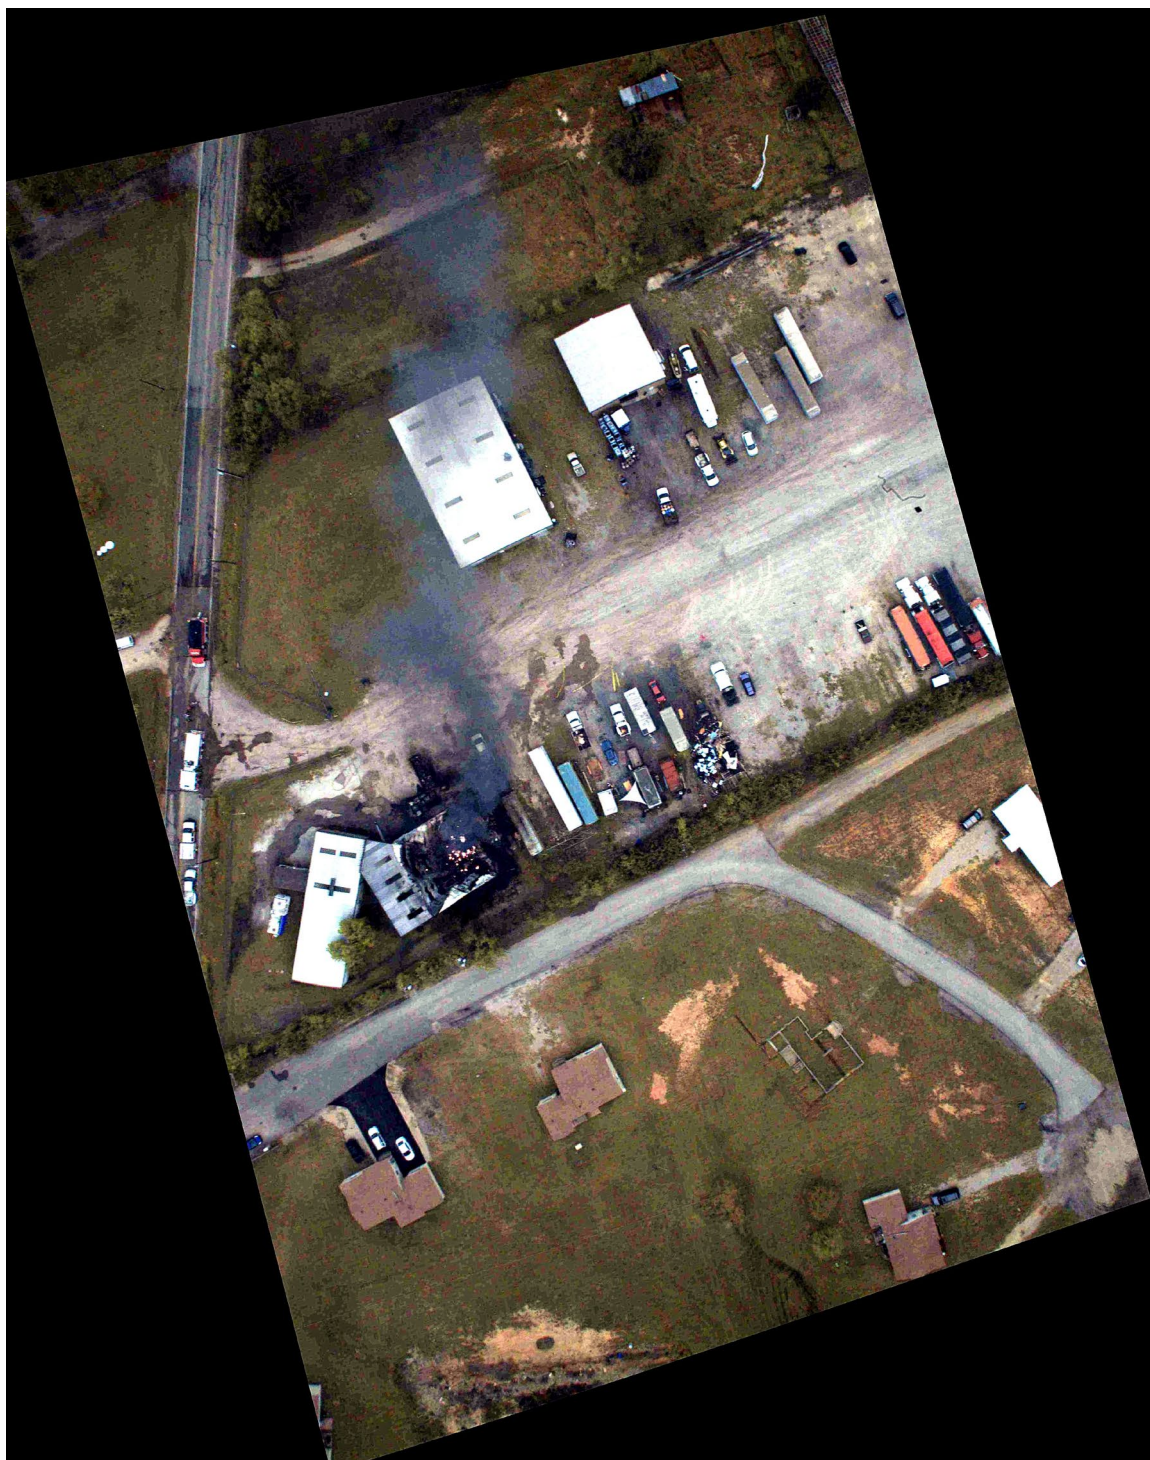
A full set of high resolution aerial digital photography were collected as part of the flight. Figure 6 shows a representative image collected as part of Run 2. This image has been ortho-rectified with the top of the image being north. An immediate feature of the image is the faint plume moving toward the north. The facility which is located in the center-left of the frame clearly shows damage to the roof. Figure 7 shows a typical oblique image collected from the right side of the aircraft. This image is not geo-

Figure 6: Aerial image Clean Solvents Recycling

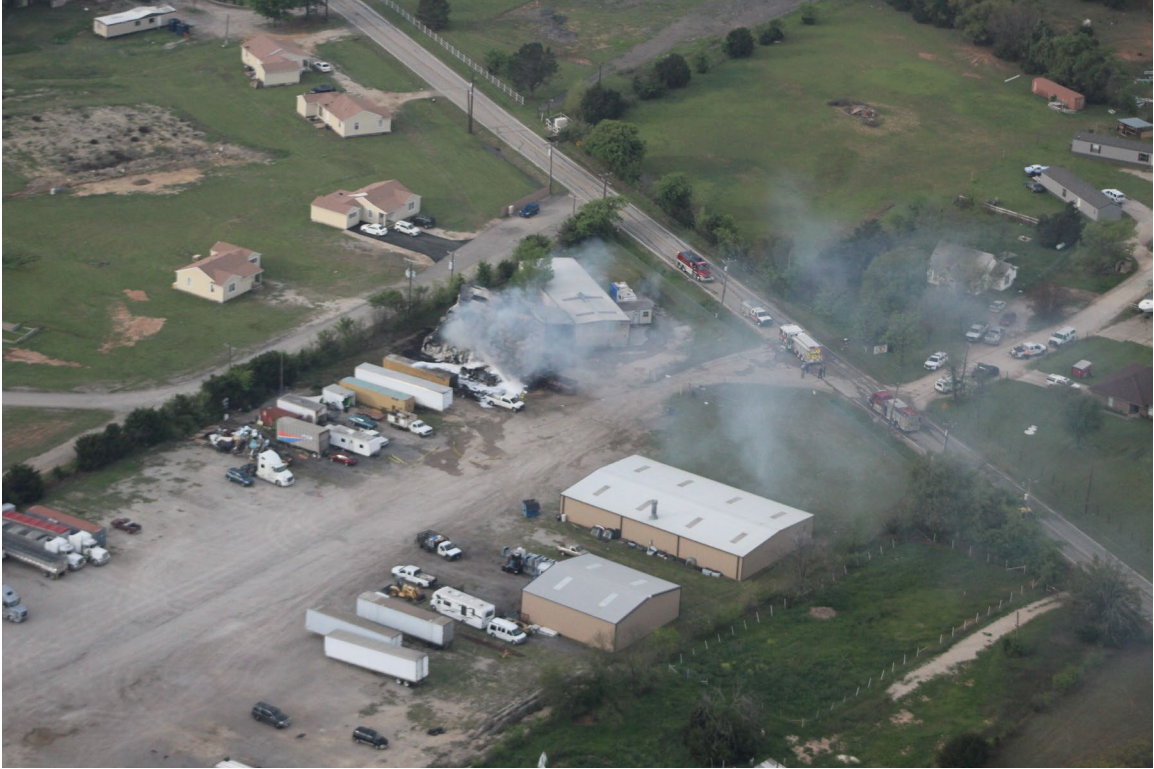
rectified. The top of the image is looking to the south. Examination of the image clearly shows the extent of firefighting foam around the facility and the presence of a small amount of white smoke moving generally to the north.

Figure 7. Oblique Image, Clean Solvents Recycling
